Renault Laguna

RATING	SCORE

ADULT OCCUPANT ★★☆☆☆	17 Front: 6 Side: 11

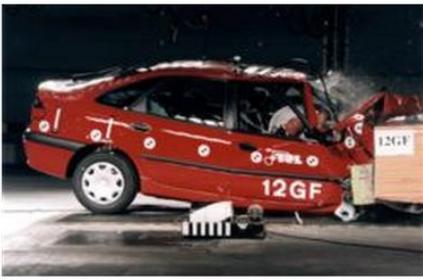
The driver's screen pillar was pushed backwards by 145mm (5.7in). The driver's door could not be opened by hand after the test and tools had to be used. The passenger's door could be opened normally. The steering wheel moved backwards by 94mm (3.7in) and downwards by 42mm (1.7in). There was moderate footwell intrusion, with the brake pedal being displaced rearwards by 200mm (7.9in). The driver's head protection would have been judged as good on the basis of the instrumentation, but was down-rated because head contact on the airbag was unstable. Neck protection was good, however, and the restraint system was effective in keeping the driver's chest away from the steering wheel. Load-limiting seat belt mounts worked effectively and the dummy measured a low risk of chest injury, although intrusion into the cabin at facia level posed a hazard to different-sized drivers or those seated much nearer to or farther away from the steering wheel. The driver's left knee hit the steering column cladding and the column adjustment lever, posing a significant level of injury risk, though this would not have increased had the knee struck in a slightly different position horizontally or vertically. However the column adjuster bracket could have caused localised damage to the knee. The driver's right knee hit the facia near the fuse box. He ran a major risk of knee, thigh and pelvis injury. If that

knee had hit slightly to the left, the column support beam or the ignition lock could have been struck. A slightly higher knee position would also have led to contact with the ignition lock. If the knee had penetrated slightly further, the column lock and support beam could have been hit and both of these could have produced localised damage to his knee. Readings from the test dummy suggested 'poor' protection for its left lower leg and 'weak' protection available for its right lower leg. The amount of footwell intrusion suggested a likelihood of both feet and ankle injury. The passenger in the front impact rated as a low injury risk generally, although there was a slightly higher chance of left lower leg injury noted. The results for the passenger dummy were not modified on the basis of any structural damage to the car.

High-impact forces from the Laguna's side were measured by the dummy's ribs, resulting in protection to the chest being assessed as poor. Head and pelvis protection for the driver were judged as good, while protection for his abdomen was assessed as 'adequate'.
