# Peugeot 306

RATING	SCORE

<b>ADULT OCCUPANT</b> ★★☆☆☆	<b>18</b> Front: 8 Side: 10

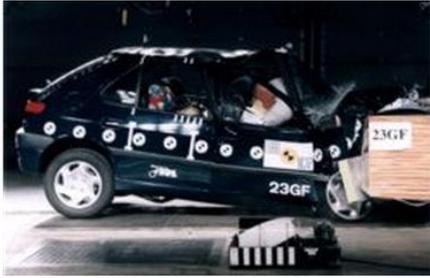
The passenger compartment maintained stability during the impact. The driver's head contact on the airbag just remained stable and the steering wheel was pushed rearwards to a limited extent. There was also moderate intrusion of the windscreen pillar. Chest protection for the driver was weak. Stiff structures in the steering column area increased injury risks for the driver's upper legs and pelvis. There was also a risk of direct injury to the knees. Protection of the lower legs and the feet and ankles was adequate and footwell intrusion was moderate.

Side impact protection was good enough to meet forthcoming legislation even without door beams or airbags. The top rib was most heavily loaded where it lined up with a plastic clip behind the door trim. The driver's abdomen was hit by the arm rest and the pelvis was hit by door trim backed by a thick foam block.
