# Toyota Corolla

RATING	SCORE

<b>Hand of drive</b>	LHD
<b>Tested model</b>	Toyota Corolla 1.3 Sportif
<b>Body type</b>	5 door Translation not found
<b>Year of publication</b>	1998
<b>Kerb weight</b>	1060

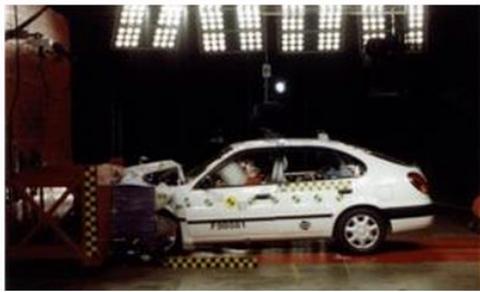
The Corolla achieved a good three-star rating and came close to gaining four stars. The car's structure performed well in the frontal crash and the driver's door operated normally after the impact. In the side-impact test, the car's weakest aspect was protection for the driver's chest. That said, it was good enough to meet legislation to be introduced for new models in October. Pedestrian protection earned two stars. The bumper area needed work to improve protection, however.

The driver's door was almost undamaged: it supported the door aperture and helped the passenger compartment remain structurally stable. The facia support tube lower mounting was starting to pull away from the door pillar. The driver's head contact with the airbag was central and remained stable. The impact areas around his knees presented hazards, however, especially if his position at the wheel differed from that of the test dummy. And the steering column mount and lock presented particular risks. The column was partly shielded to protect his knees but some other areas remained unprotected.

The driver's head hit the central door pillar, breaking the cover over the belt loop. Padding within the pillar cover

was depressed, resulting in low head acceleration. His lower rib was the most heavily loaded after being struck by the rear of the door and the central pillar.
