Nissan Primera

RATING	SCORE	Front: 8	Side: 11

Hand of drive	RHD
Tested model	Nissan Primera 1.6 GX
Body type	5 door hatchback
Year of publication	1997
Kerb weight	1219

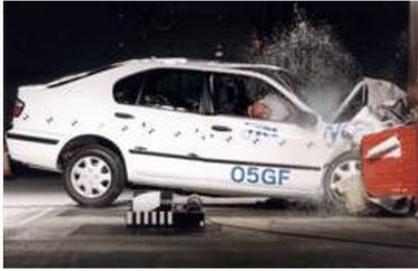
The new Primera, launched in October 1996, earned a three-star front- and side-impact rating. It performed well in the frontal-impact test, although footwell intrusion was extensive and stiff structures in the lower fascia area posed a hazard to the driver's knees, thighs and pelvis. The Primera met coming 1998 side-impact legislation for new models. The car tested had a standard driver airbag that worked well. Side impact airbags will be offered as options later this year.
