## NISSAN MICRA

RATING	SCORE

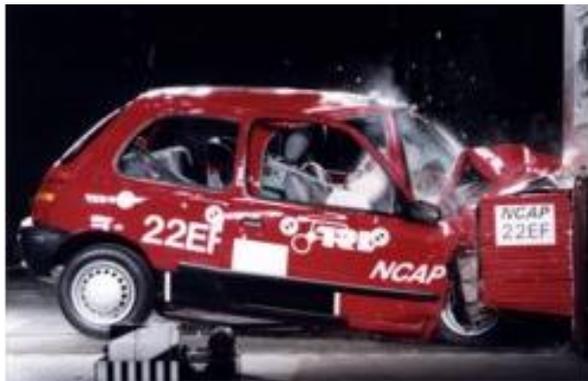
The Nissan Micra was awarded two stars for protection in the frontal- and the side-impact tests. However, with just a little improvement in performance, the car would have been moved up into the three-star category. In the frontal-impact crash test, the Micra failed to meet the new criteria for the left knee impact and for protection of the right lower leg. Under side-impact conditions, it failed to meet the abdomen requirements. On the other hand, the car did meet the requirements that relate to the degree of steering wheel displacement. In the frontal-impact crash test, the Nissan Micra's major problems related to intrusion, particularly at knee and footwell level, although the passenger compartment did remain stable. Improvements in safety performance are also needed in the knee-impact area. For the side impact, improved protection is required for the abdomen while care is taken not to transmit too much loading to the chest or pelvis.

In the frontal impact, the Micra suffered moderate structural deformation, and the passenger compartment maintained its stability. There was good control of steering wheel intrusion – the wheel moved back into the cabin by 60mm – but the test results showed there to be an excessive intrusion of the footwell. The driver's door failed to transmit loads effectively, allowing a moderate collapse of the door aperture and also intrusion of the fascia. After the test, the driver's door could not be opened – even with extreme hand force – and tools had to be used. The passenger door opened normally. The driver's head protection was good and the head's contact on the airbag was stable. Neck protection was also found to be good. Seat belt loading of the chest was measured as adequate but this was downrated to a score of marginal because of the intrusion of the fascia. The left knee impacted on the steering column cover, bent the column adjuster and then hit the rigid steering column and its mounting bracket. The dummy's right knee hit the car's fascia and pushed it on to a tube supporting the steering column, distorting a bracket which was mounted to it. For both knees, there were stiff structures which could concentrate loads on part of the knee and further penetration into the fascia would have resulted in sharply increased loads. The right knee would also have received greater loading if it had impacted the fascia in a slightly different position horizontally. The left knee protection was poor on the basis of dummy instrumentation and could not be downrated, but the right knee was downrated to weak to account for these points. The excessive footwell intrusion led to poor protection ratings for the right lower leg and for feet and ankles. Protection of the left lower leg was rated as marginal. On the front passenger side of the car, the Micra's protection of the head, neck, upper and lower legs and feet was good. Seat belt loading resulted in the chest protection being adequate.

Protection from injury in the abdomen area was poor under side-impact conditions because of excessive loads which were put on the body. The degree of head protection afforded by the Nissan Micra was found to be good, while the protection offered to the chest and pelvis areas was rated as adequate.
