Mitsubishi Lancer

RATING	SCORE	Front: 4	Side: 11

Hand of drive	LHD
Tested model	Mitsubishi Lancer CLX
Body type	4 door saloon
Year of publication	1998
Kerb weight	1244

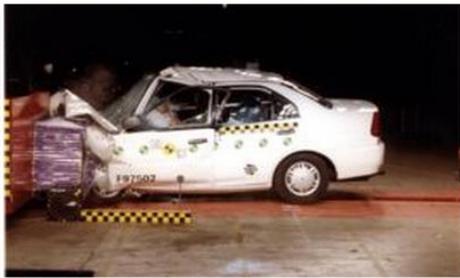
Of the two stars awarded, the last is 'flagged' to indicate that the car provided only poor protection for the driver's chest in the side-impact test. It failed to meet legislation that will apply to new models from October. Also, the car's structure became unstable in the frontal impact and the floor pan ruptured. Its protection for pedestrians rated a little above average, however.

The driver's door lost structural strength. Its inner and outer panels and horizontal beam separated from its front. Floor and footwell joints ruptured, too. The airbag deployed slightly to the driver's left and his head appears to have just 'bottomed out' on the bag. Stiff structures were present which could increase loading on the driver's upper legs and damage his knees. His right leg also risked injury from loading below the knee being transmitted through the joint. There was also a moderate risk of both front occupants suffering chest injuries from the seat belt loading.

Although door intrusion remained fairly vertical all the driver's ribs were highly loaded. His head struck the door pillar belt swivel but acceleration remained low. Loading of the abdomen and pelvis were relatively low, possibly because of high chest loads. His seat base twisted downwards on the door side and upward on
