# Toyota Avensis

RATING	SCORE	Details

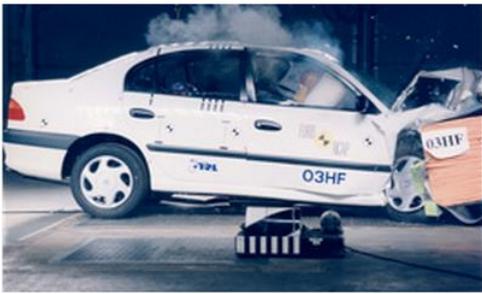
## Adult occupant protection

Frontal impact driver

Frontal impact passenger

Side impact driver

- GOOD
- ADEQUATE
- MARGINAL
- WEAK
- POOR

The passenger compartment remained stable after the impact, all doors could be opened and closed normally and intrusion levels were low. The front airbags provided stable support for the occupants' heads. Belt loading to the driver's chest resulted in marginal protection but that of the passenger's was adequate. Stiff structures around the steering column increased the risk of injury to the driver's upper legs and pelvis and there was a risk of injury to the knees themselves. Protective webbing was moulded into the steering column shroud, covering part of the steering lock. A bracket was fitted to limit rearward displacement of the brake pedal.

Even without side airbags, protection for the driver's chest was adequate. The seat design helped to protect him from impact with the door and central pillar. Protection for his abdomen was good and for his pelvis, adequate.
