Citroen Saxo

Adult occupant protection

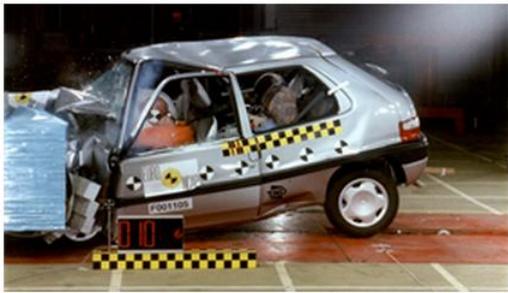
The Saxo is an older design which is no longer being developed by Citroen, and a new model is about a year away. The performance is at the bottom end of the cars under test. The child restraint performance was better than for a number of newer cars tested in this phase of Euro NCAP.
